# Remediation of Storm Water Entering Lake Michigan through the Installation of Native Wetland Plants

In Racine, a storm sewer outfall emptying directly into Lake Michigan was engineered to re-direct the first-flush, dirtiest, storm water to a series of vegetated infiltration/evaporation beds leaving the original outlet as the overflow site. Research conducted in 2003 demonstrated that these beds had significantly less (~66%) bacteria exiting them compared to the overflow outlet although they frequently accepted large volumes of storm water containing concentrations of *Escherichia coli* in excess of 200,000 most probable number (MPN) per 100 ml of sample. It was felt that the vegetation, placed in the beds for aesthetic purposes, also served as an effective means of reducing the bacterial content of the storm water. Therefore, installing native wetland plants at the overflow site, where none currently existed, might serve to further reduce the amount of bacteria available for transport to Lake Michigan. The unknown variable was whether or not the overflow site could be successfully vegetated since it was prone to extreme flash floods, not contained in a basin and in appearance re

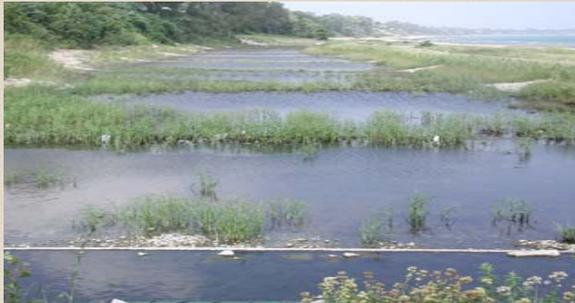
Figure 1 – Vegetated infiltration and evaporation beds installed in Racine to accept and retain first flush storm water.

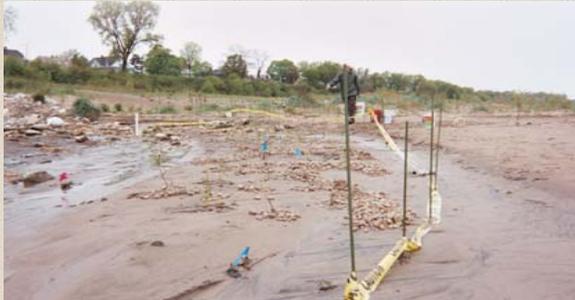
Figure 2 – Initial installation of native plants at the English Street storm sewer overflow site took place on May 14, 2004 (Dr. Stephen Pedley, Univ. of Surrey, UK pictured).

- Burlap weighted with 2-inch washed stream bank stone [rushes] (Figure 2, forefront)
- Burlap anchored with garden staples [sedges] (Figure 3)
- Burlap weighted with 4"-8" field stone [rushes] (Figure 4)

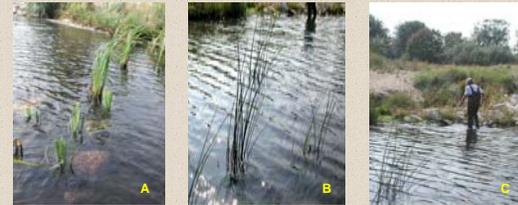
Figure 8 (A, B, C) – Appearance of transects (August/September 2004). [A-sedges, B-rushes, C-both]
